# RRWMB

## BOIS DE SIOUX WATERSHED DISTRICT

# LAKE TRAVERSE PROJECT UNDERWAY

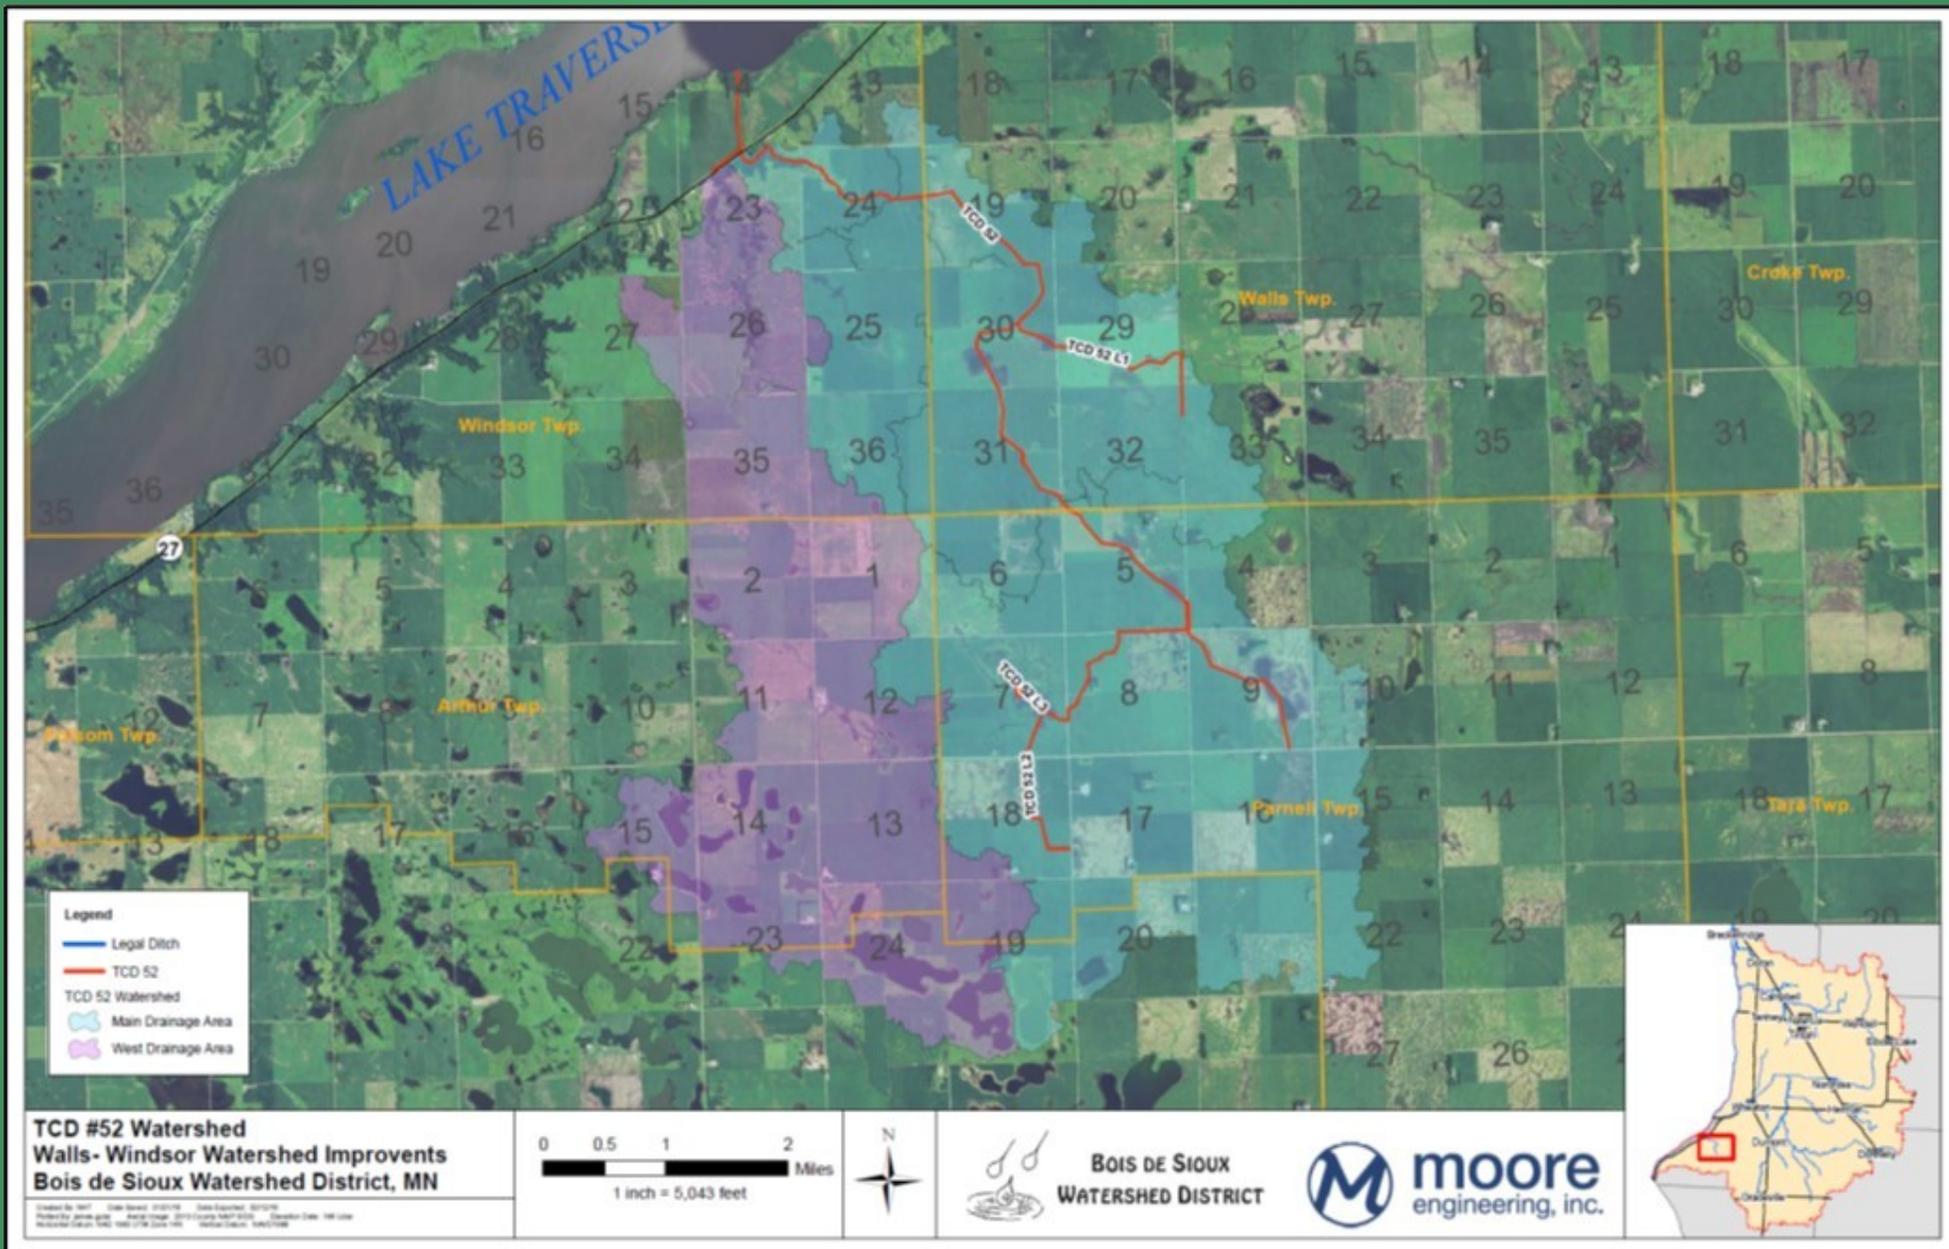
## Project Location

Public Waters including the outlet reach which empties into Lake Traverse. Phase 1 of the stabilization project will begin at the outlet into Lake Traverse and proceed upstream to the first road crossing at State Highway 27. This 3,500 lineal foot stretch of public water has become a severely eroded gully and has discharged approximately 50,000 cubic yards of sediment since 1951 into Lake Traverse. This is equivalent to 5,000 standard dump truck loads of sediment. Further downstream, Mud Lake is impaired for nutrients. The map below, which can be found in the preliminary engineering report, illustrates the watershed area of the Project that drains into Lake Traverse.

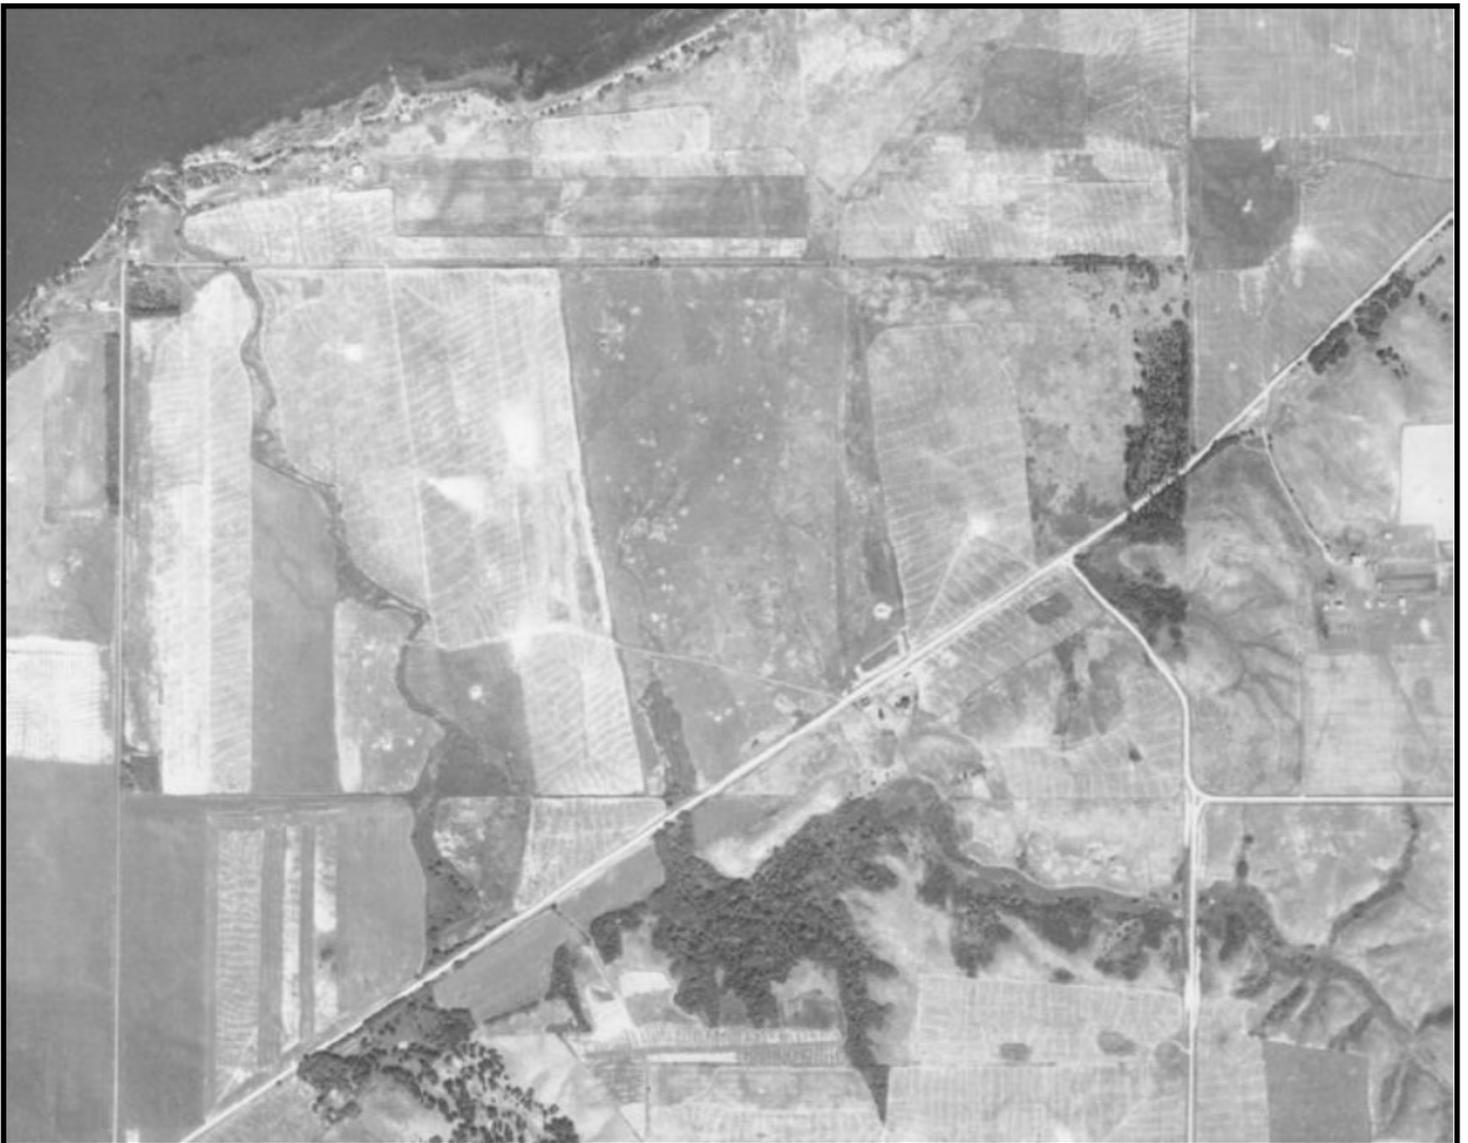
is important to stabilize the outlet reach of TCD 52 first, and we are committed to addressing other problem areas upstream from the outlet reach in future phases of the overall project plan." Much change has taken place on the landscape and below is a photograph from 1938 prior to construction of TCD 52. This photograph can be found in the preliminary engineering report for the Project.

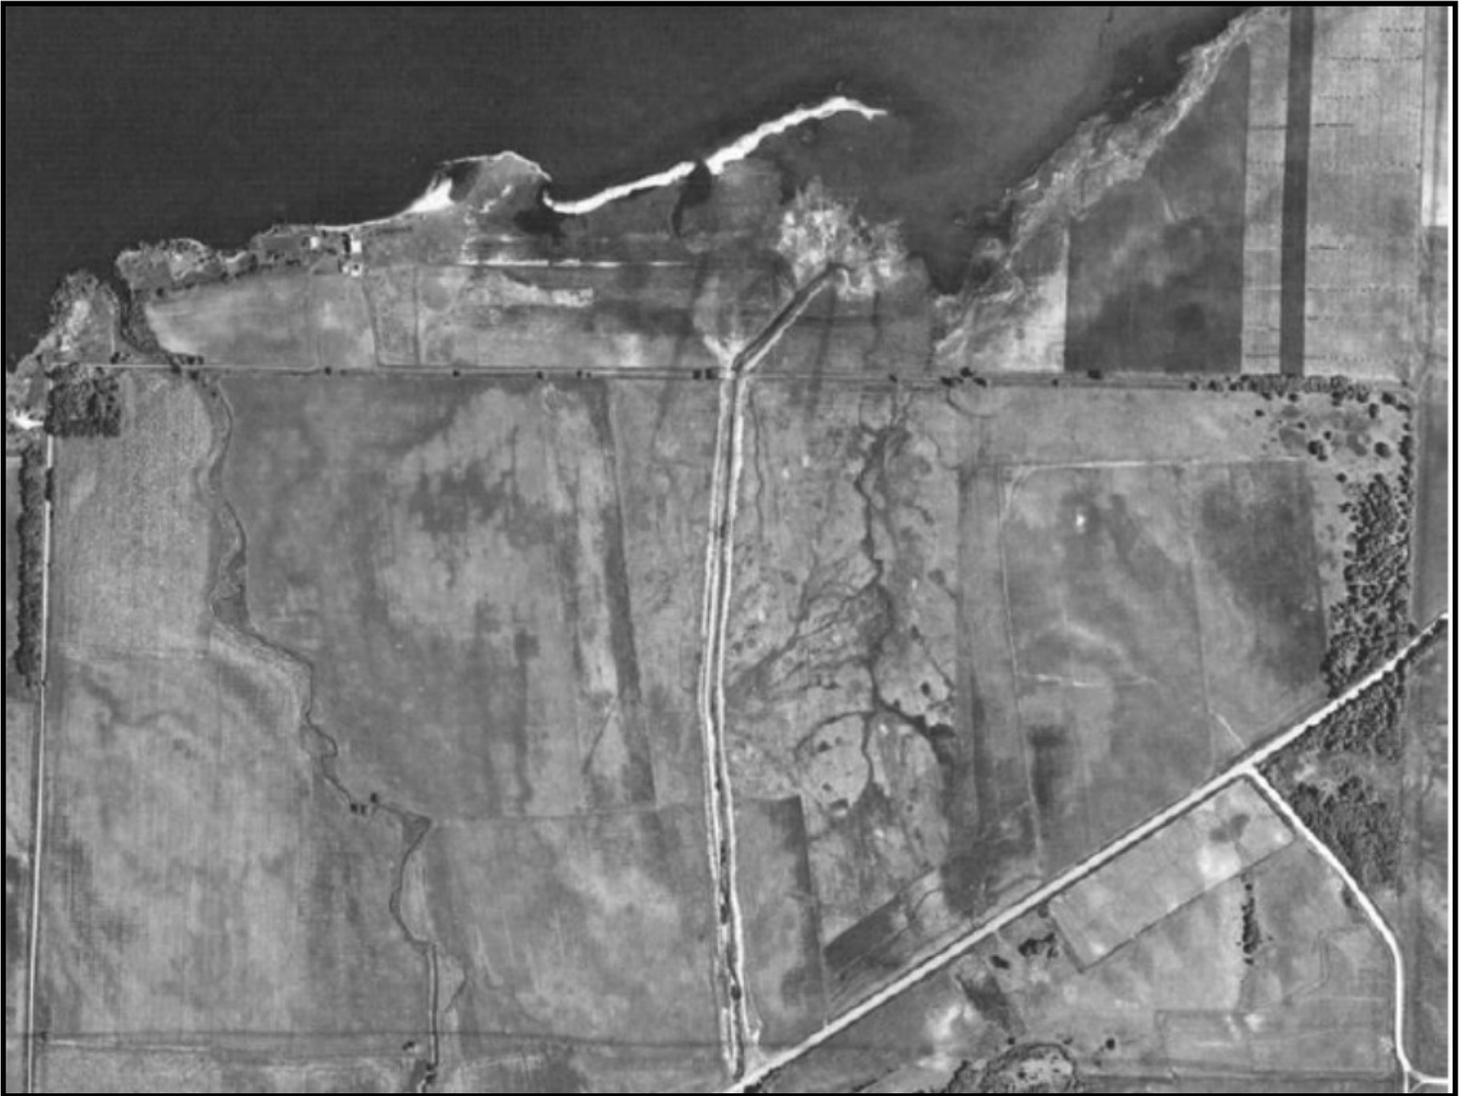
The 1951 photograph above, which can be found in the preliminary engineering report for the Project shows original construction of TCD 52. Linda Vavra said that, “Many decades ago when the ditch was constructed, landowners had good intentions to make farmland productive and to provide adequate drainage”. However, since 1952, flooding and more intense storm events along with increased storm frequency during the growing season have led to significant

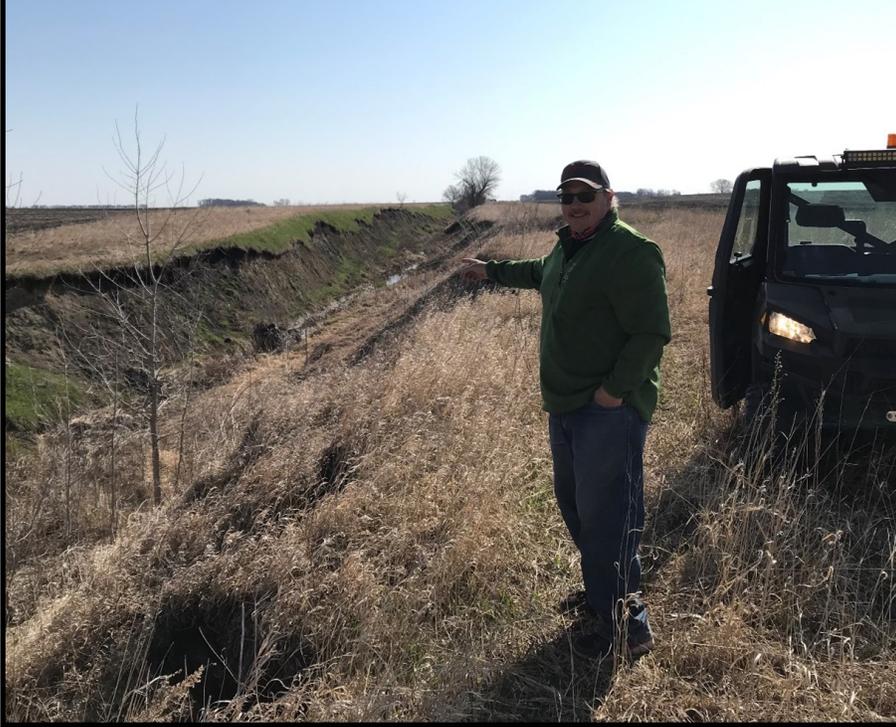
***BdSWD Technician Troy Fridgen pointing out severe bank sloughing and erosion in the upper reaches of the Project watershed area. Photograph courtesy of Robert Sip, RRWMB Executive Director – April 22, 2021.***

Troy is responsible for inspecting 426 miles of 103E drainage systems in the BdSWD, with approximately 142 miles per year being inspected and he said that “This is probably the worst erosion I’ve seen in my career”. Top left is a photograph of Troy showing erosion areas to Robert Sip, RRWMB Executive Director.

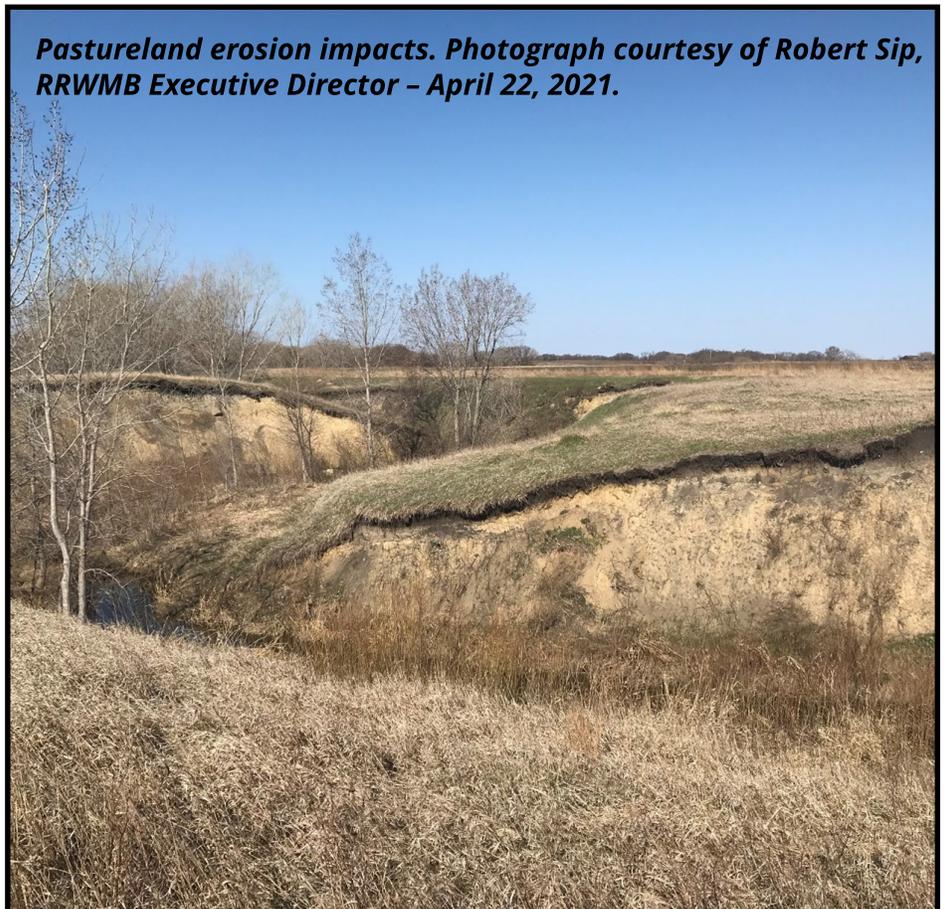
There have also been impacts to pasturelands as indicated in the photograph below. While pasture areas in the Project area are relatively stable, with adequate vegetation, areas immediately adjacent to the ditch are sloughing into the bottom of the ditch. In some areas, the ditch is several feet deep and can only be surveying by a drone with LiDAR capabilities.

***Pastureland erosion impacts. Photograph courtesy of Robert Sip, RRWMB Executive Director – April 22, 2021.***

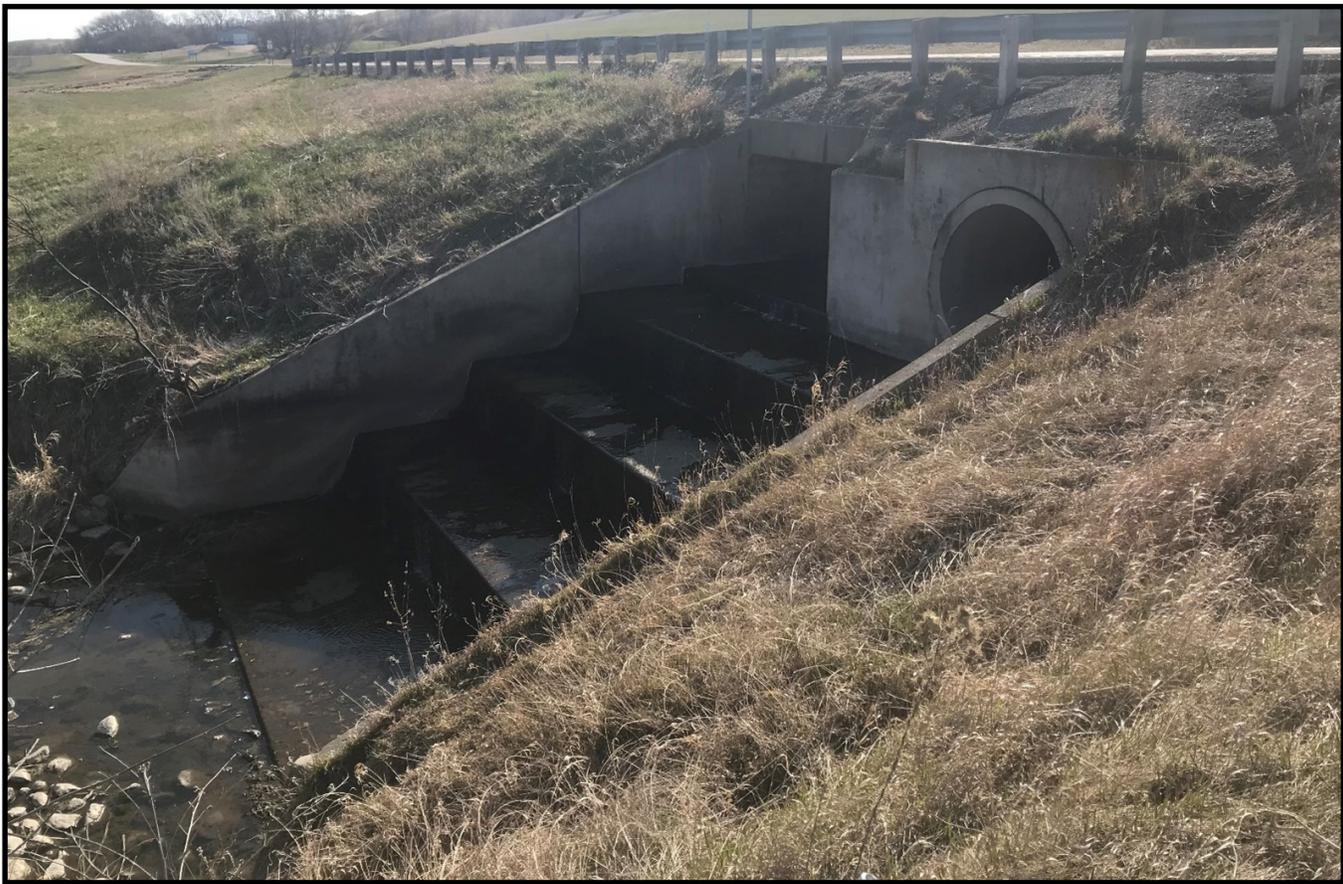
According to Jim Guler, one of BdSWD’s engineers, “The BdSWD has been coordinating the Project with input from Minnesota DNR fisheries specialists”. Jim further stated that, “Eventually the culvert underneath Minnesota State Highway 27 will be replaced, and it is likely the State of Minnesota will include a means for fish passage”. The existing culvert does not allow fish to move upstream into the watershed to spawn in the spring due to the design. Currently the culvert under Highway 27 is slowly undercutting as indicated in the photograph below and the right-of-way is in jeopardy of continued encroachment as a result of bank erosion and sloughing.

***Minnesota State Highway 27 culvert. Photograph courtesy of Robert Sip, RRWMB Executive Director – April 22, 2021.***

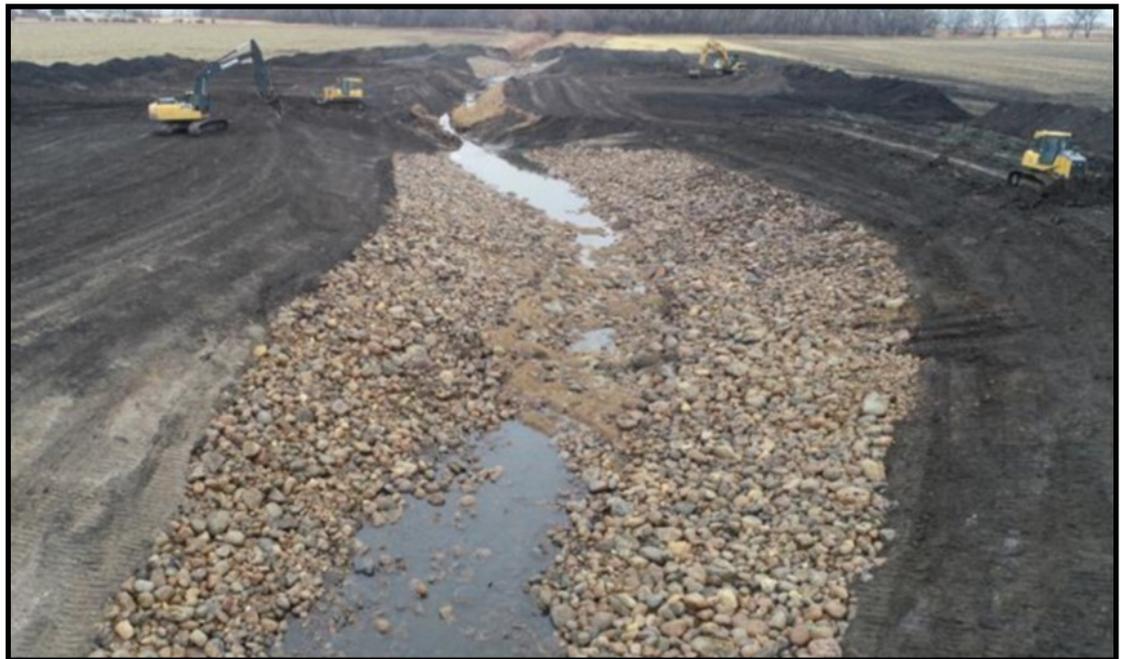
While the Project is primarily focused on reducing erosion and sedimentation and augmenting fishery habitat, the project will work towards preserving flood storage in Lake Traverse by limiting the amount of sediment currently entering the Lake. Phase 1 also incorporates the use of four separate rock riffle areas that will contribute to fishery habitat and sediment management. Phase 2 will incorporate five additional riffle areas. The next three photographs illustrate construction, final placement of rock riffles, and stockpiles of various sizes of aggregate.

***Phase 1 construction in November 2020. Photograph courtesy of the BdSWD.***

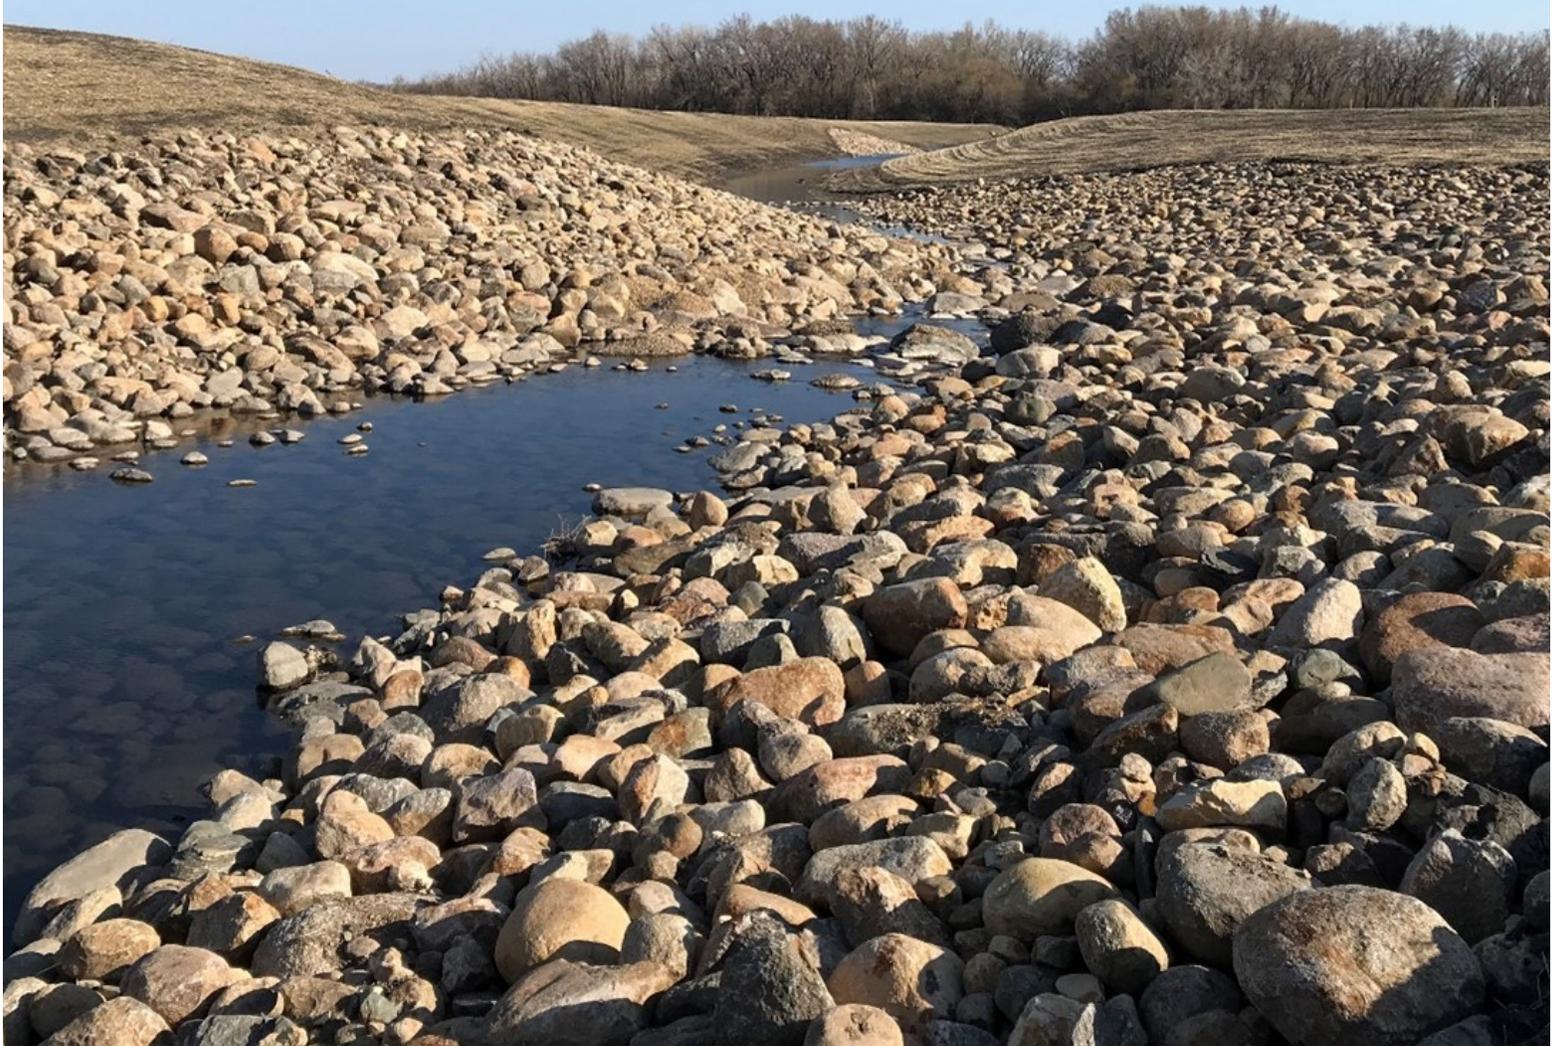
Jim Guler indicated that, “A variety of different sizes of aggregate have been used thus far ranging from small 3/4-inch chinking rock to five-foot wide boulders. Chinking rock is used for filling the voids of larger boulders and aids in fish passage. Jim also stated that, “Aggregate resources came from local sources and that the larger boulders were individually selected due to their size and shape for the specific purpose of creating stepped weirs”.

***Close up view of a rock riffle in Phase 1. Photograph courtesy of Robert Sip, RRWMB Executive Director – April 22, 2021.***

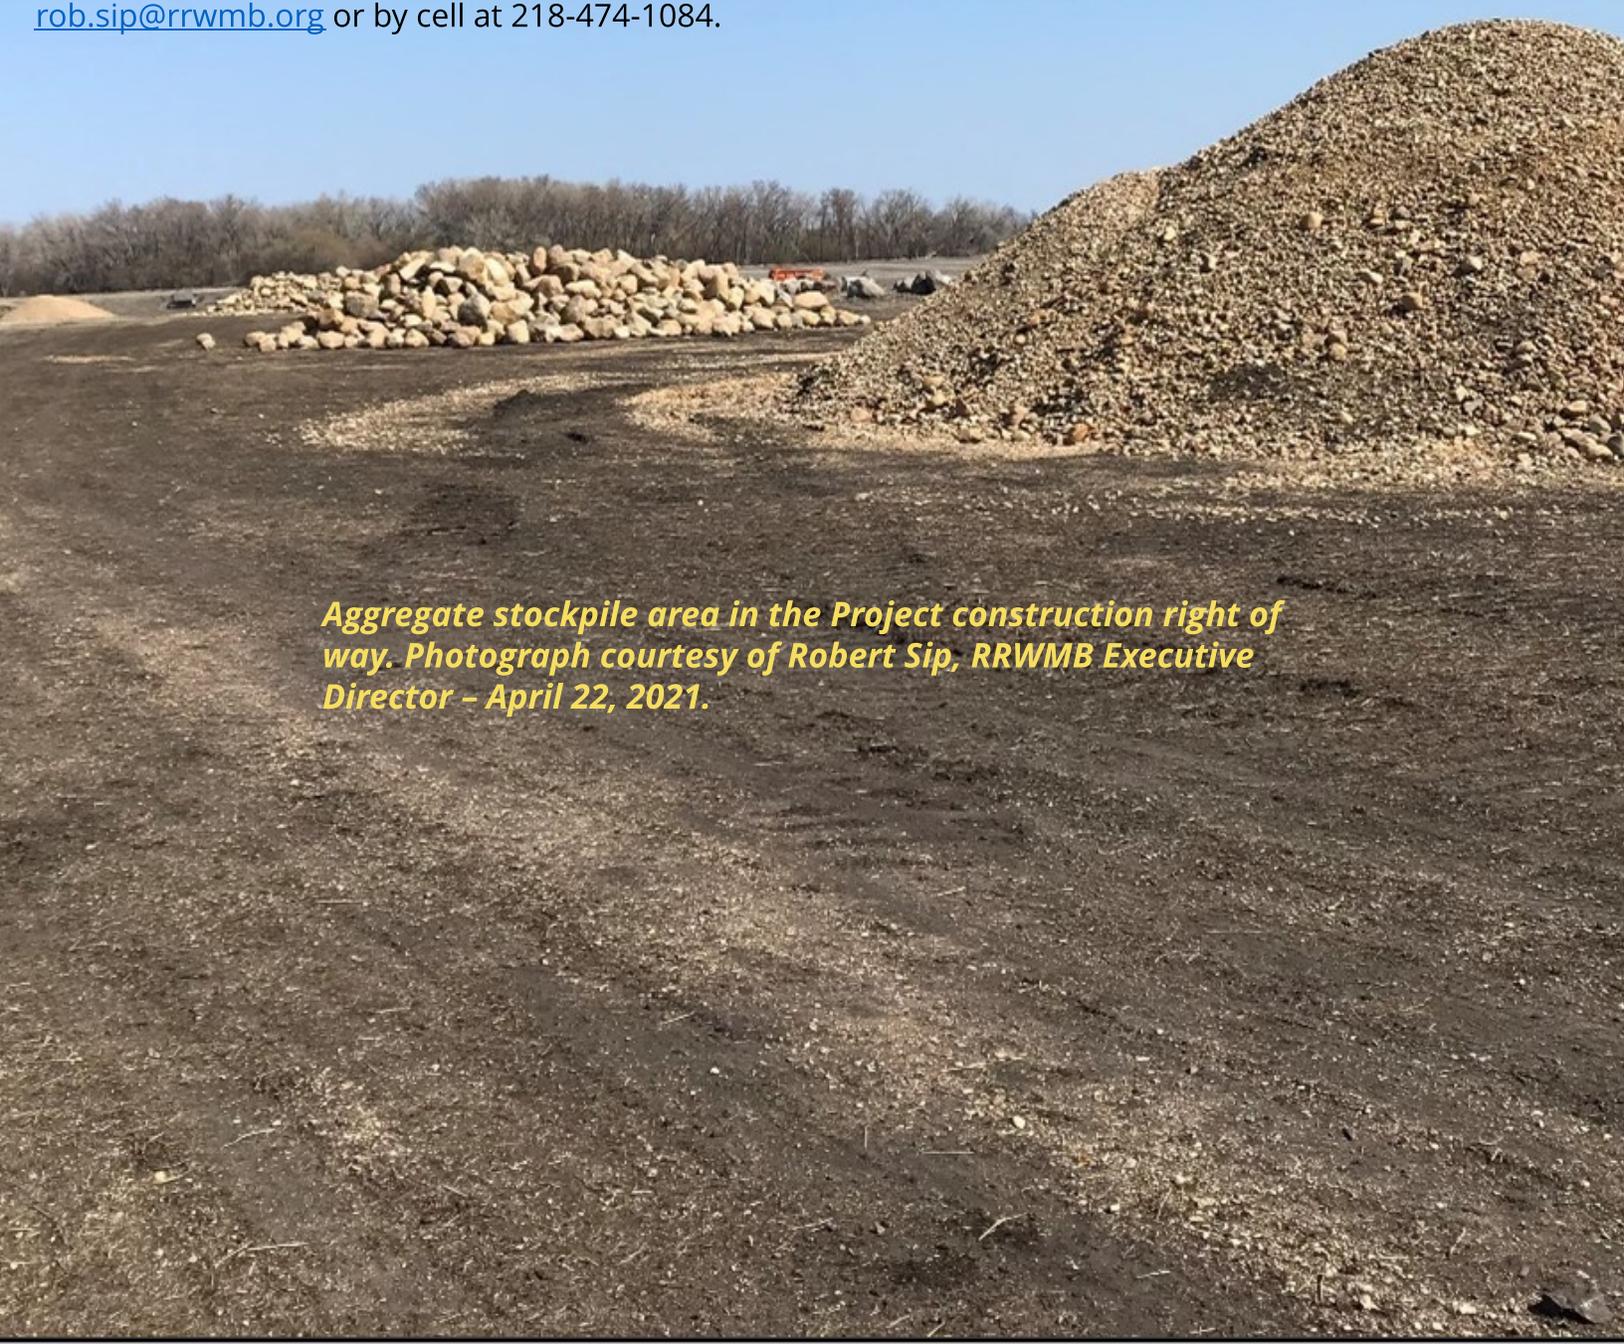
Regarding the selection of aggregate resources for the Project, “The BdSWD received input from the Minnesota DNR and a subcontractor that specializes in rock riffle design for projects such as this,” said Troy Fridgen. Troy also mentioned that, “The subcontractor actually rode in the backhoe and provided instruction to the backhoe operator for exact placement of individual boulders”. The following photographs include a closer view of aggregate sizes along with the construction right-of-way area where aggregate is currently stockpiled.

***Aggregate stockpile area in the Project construction right of way. Photograph courtesy of Robert Sip, RRWMB Executive Director – April 22, 2021.***
